High-Strength Micropiles Solve Problems at Seismic Retrofit Site

The Sharp Memorial Hospital campus in San Diego, Calif. has two towers – the South and Central Towers – that required seismic retrofitting to remain in service beyond January 1, 2015. As part of the seismic retrofit of the Central Tower, the contractors chose to use high capacity, closely spaced, micropiles to strengthen the structure's foundations.

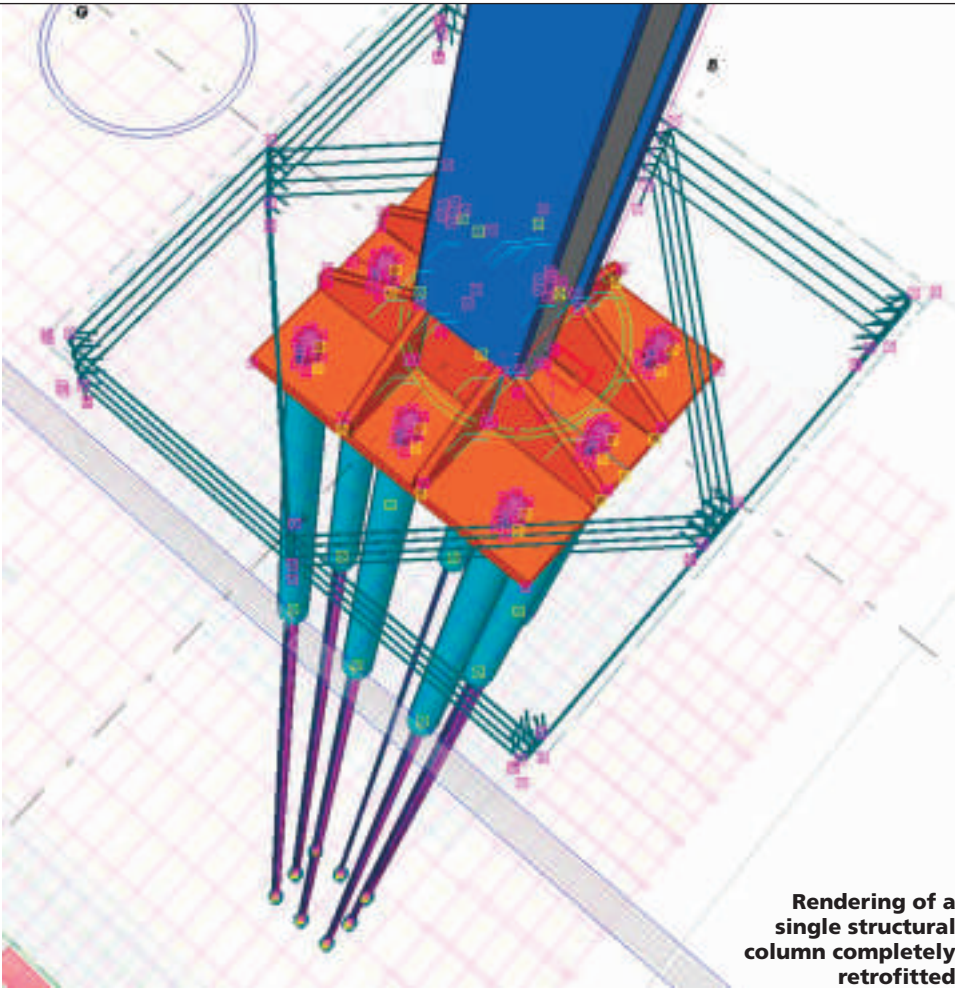
Rendering of a single structural column completely retrofitted

For the Central Tower structure to be designated SPC-2, foundation improvements were necessary at 10 steel columns. CJA needed 76 micropiles for the foundation improvements. Nine of the 10 columns were designed with 8 micropiles. One column was designed with only 4 micropiles due to conflicts with existing improvements. We performed the micropile work in four phases to maintain access through the hospital lobby and required paths of egress.

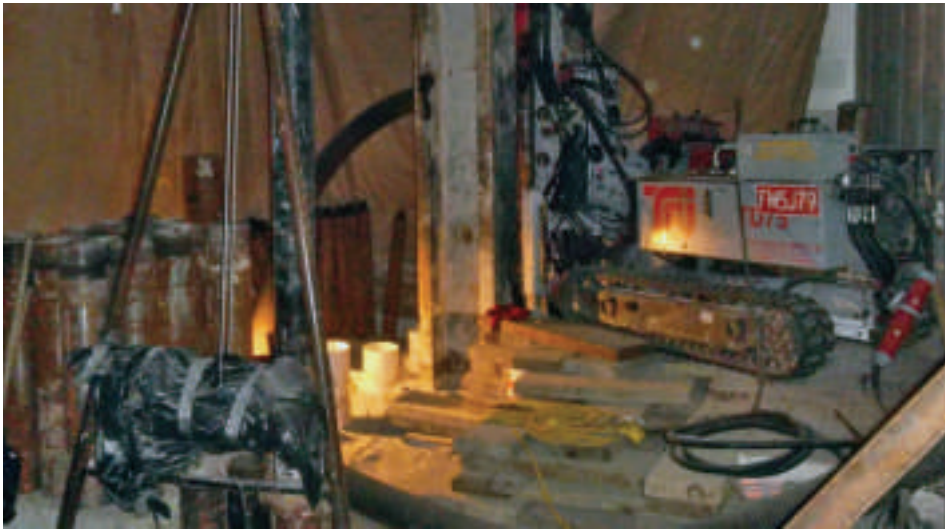
In the enclosed work area, the TEI TD75 is in drilling position on a difficult access hole

To stay in compliance with the Sharp Infection Control policy and general best management construction practices, all equipment operated inside the hospital was electric. All equipment powered by diesel engines was staged outside the hospital. CJA used its electrically powered TEI TD75 drill rig inside the hospital. The pieces of equipment staged outside the hospital were a Sullair 900XHH Air Compressor, an Obermann VS100 Grout Plant and Hurricane 828 Vacuum. The TEI TD75 was selected for its compact size, and ability to work in low overhead conditions. The TEI TD75 was also able to track beneath a standard sliding door, necessary to access the work areas.

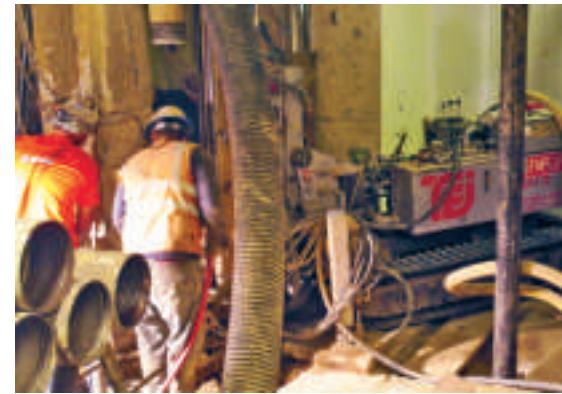
Workers inspect a micropile excavation. Vacuum is shown connected to the duplex swivel.

All spoils were exhausted using compressed air, and controlled at the top of the drill string with a flushing bell and spoil swivel manufactured by OCI. Once spoils were exhausted from the drill string they were directed into a sealed separation tank. Then the workers connected the vacuum line to the top of the separation tank. In the separation tank, the heaviest drill spoil would fall out of suspension and be contained, while the lighter particles, mainly dust, were removed by the vacuum line. When full, the separation tank was removed from the work area and emptied in the staging yard outside of the hospital. Using a separation tank in addition to a small amount of water injection during drilling created a nearly dust-free micropile excavation.
