A CASE HISTORY ON DESIGN, CONSTRUCTION, AND PERFORMANCE OF STONE COLUMN GROUND IMPROVEMENT BENEATH AN MSE EMBANKMENT

Karen Dawson, P.E. and Seungcheol Shin, Ph.D., P.E., CH2M HILL, Bellevue, WA, USA
Suthan Pooranampillai, Ph.D., AMEC E & I, Edmonton, AB, Canada
Dominic Parmantier P.E., Condon Johnson & Associates, Inc., Kent, WA, USA

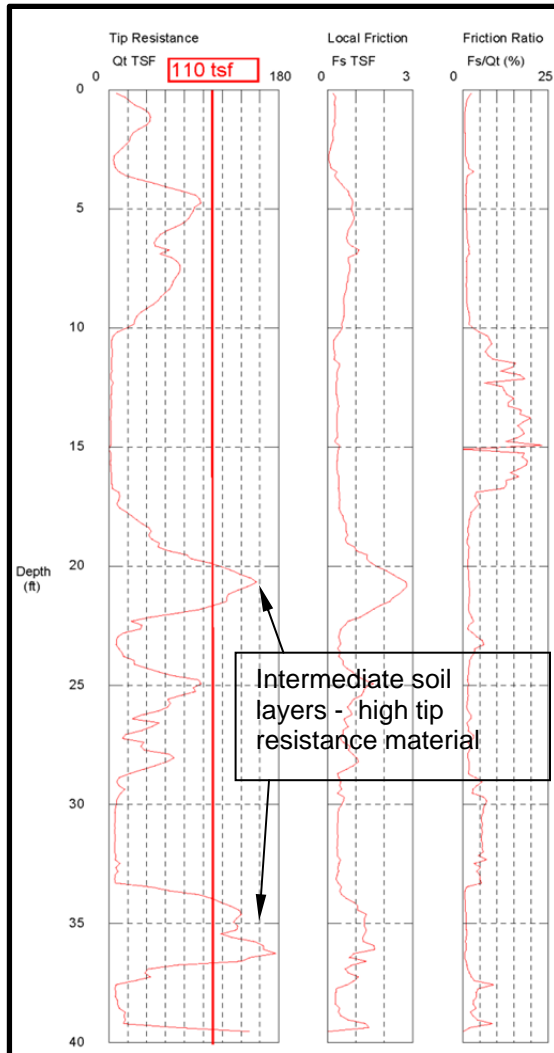
Figure 2. Typical CPT Log

The thickness of the alluvial deposits ranged from about 30 to 70 feet. The alluvial deposits were underlain by very dense, glacially consolidated granular soils. A transitional zone was located between the alluvial deposits and the glacial deposits. The transitional zone generally consists of inter-layers of medium dense to dense sand/gravel and soft to firm silt. The groundwater table was typically 5 to 10 feet below the existing ground surface. Piezometers installed in the glacial deposits indicated that a confined aquifer exists in the glacial deposits. The measured pressure head was approximately at the ground surface. A typical CPT log is shown in Figure 2.

quantified based on an engineering judgment of the aggregate material. The stone volume over any 10-foot deep column length had to equal or exceed 80 percent of the design volume and the volume over the entire length had to equal or exceed the design volume per column. Provisions were made to allow lower than design volumes of stone if equipment response indicated penetration through material that exceeded a target density equivalent to a CPT tip resistance, q_t , of 110 tons per square foot (tsf) or a standard penetration test (SPT) N_{60} value of 24 blows per foot. Comparison of target CPT tip resistance with the limiting value of 110 tons per square foot (tsf) can be seen in Figure 2.

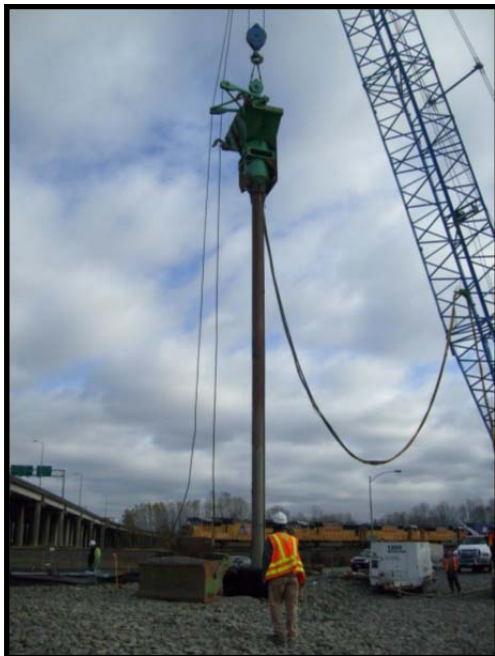
Figure 4. Equipment set-up showing crane mounted vibro-probe

Due to the quantity of stone column ground improvement that needed to be carried out, coupled with an aggressive construction schedule, two installation units were mobilized. The depths of the stone columns were anticipated to range from 30 feet to as much as 70 feet in the existing embankment area. This required that the length of the probe from probe tip to top of skip bucket needed to be adjusted accordingly and suitable base cranes were selected. Manitowoc 4000 and 4100 crawler cranes were chosen as the base carriers. Bottom feed electric probes (V-23) were utilized to place the stone directly at the bottom of the individual columns. Figure 4 shows the equipment arrangement used for carrying out the work.

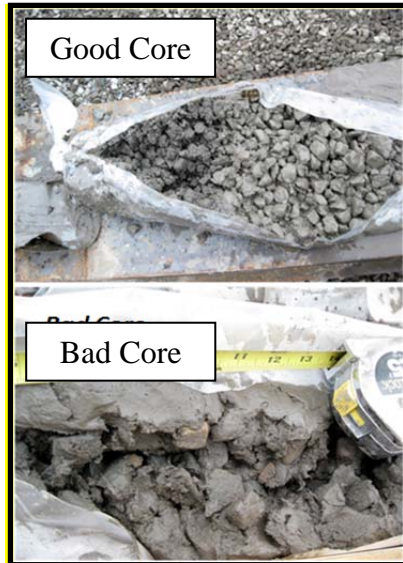
Figure 8. Comparison of Sonic Cores

Rotary sonic coring of the columns was also performed. The sonic cores were somewhat difficult to interpret. Much of the cores contained obviously clean, high strength gravel with very little intrusion of native soil, but some of the cores included significant native material (Figure 8).

Comparing plots of percentage gravel (through visual examination) with depth to the adjacent CPT logs, for Test Section 1 (Figure 9), did not yield any obvious subsurface-related reason for the inconsistency and unexpected composition of the core. Examination of construction records suggested that the appearance of native intrusion was due to misalignment of the sonic core within the columns. Additionally, due to plugging of the probe at various times during the test column installation, the probe had to be withdrawn from the hole and unplugged before reinsertion. The probe would occasionally become plugged with quarry spalls which were placed to provide a firm working platform and

had contaminated the stone column backfill material. Withdrawal and reinsertion was also deemed as a reason for intrusion of native material.

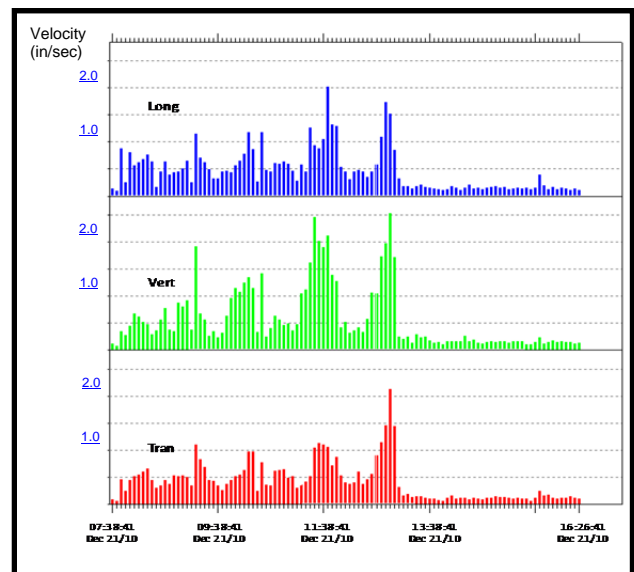
Figure 10 Vibrations Monitored at Gas Line Located 6 to 8 feet from probe

The stone columns were constructed close to an existing high pressure gas line. Vibrations were monitored continuously when equipment was operating within 100 feet of the line. A 3-channel seismograph recorded vibrations in the longitudinal, vertical, and transverse directions. Typically, vibrations were less than 0.5 inches per second. The highest recorded vibrations were 1.1 inches per second in the transverse direction when the probe was working 6 to 8 feet from the monitoring point which was directly above the gas line. Figure 10 shows the velocity record from the closest work to the gas line.

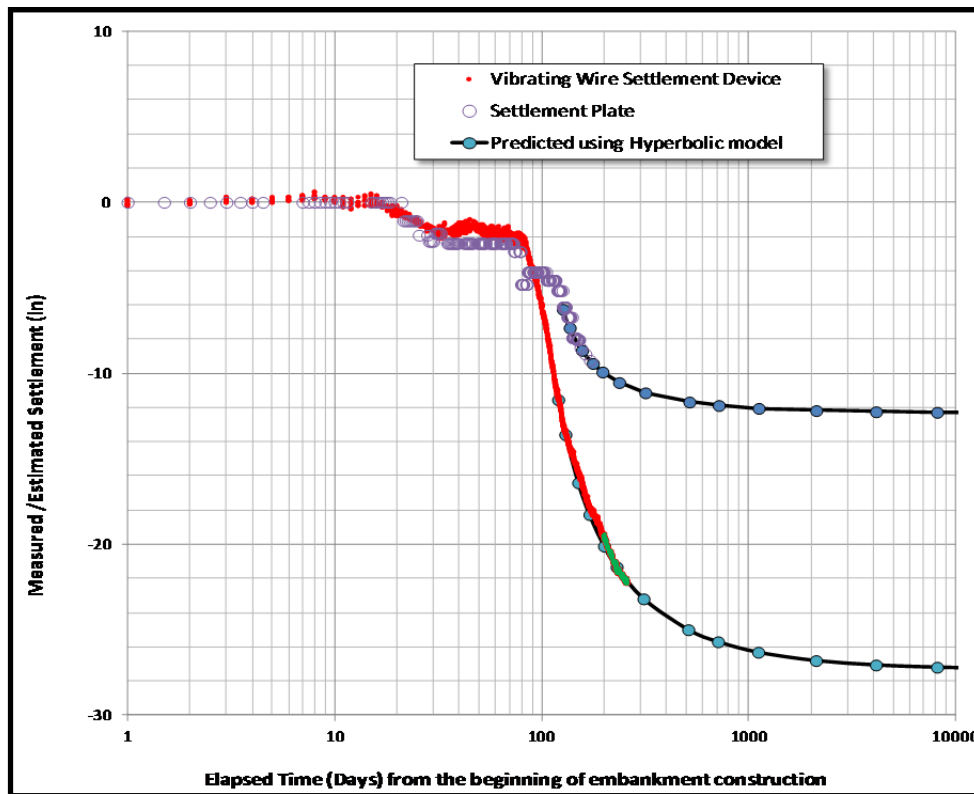
Figure 11 Typical Measured Settlement Data

of the wall face. Example plots of settlement vs. time are shown in Figure 11.

The estimated magnitudes of the primary consolidation settlement were approximately 20 and 11 inches for unimproved and improved ground respectively, without considering the 20 percent surcharge. As shown in Figure 11, the measured settlement using settlement plates was quite comparable with the estimate. However, the vibrating wire settlement devices typically indicated greater settlement than the settlement plates. The vibrating wire settlement devices were placed midway between stone columns, at least 8 inches below the top of the columns, on 12-inch x 12-inch x 1/8-inch plates, and directly under the face of the wall. The settlement plates were constructed on top of the sand drainage blanket above the stone columns, with 24-inch x 24-inch x 1/4 inch base plates, and located at least 2.5 feet in front of the wrapped face. It is postulated that these slight differences in details combined to make the measurements from the vibrating wires represent more of the unimproved ground settlement while the measurements from the settlement plates represent overall average

settlement of the improved ground.
