March 2014  
Issue No. 162  
Published by the  
United States Society on Dams

# Calaveras Dam Replacement Project

# Dam Foundations and Differing Site Conditions – Calaveras Dam Replacement Project

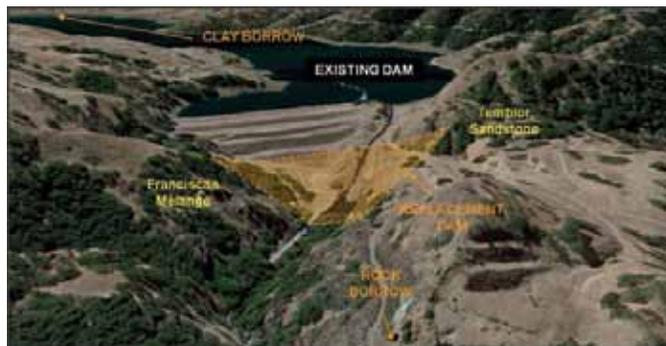
A site overview is presented in Figure 2 and a typical cross section of the new zoned rock fill dam is shown in Figure 3. The new dam will include a wide central core constructed of clay which will be obtained from an on-site borrow source located just south of the reservoir. The upstream and downstream shells will be obtained from an on-site rock borrow site and excavation into the left abutment, respectively. The materials for the internal filters and drains will be imported from off-site local aggregate quarries.

Figure 2. Site overview.

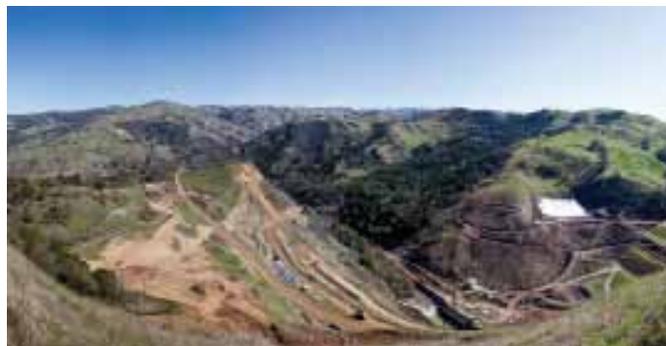
Figure 4. View from left abutment.

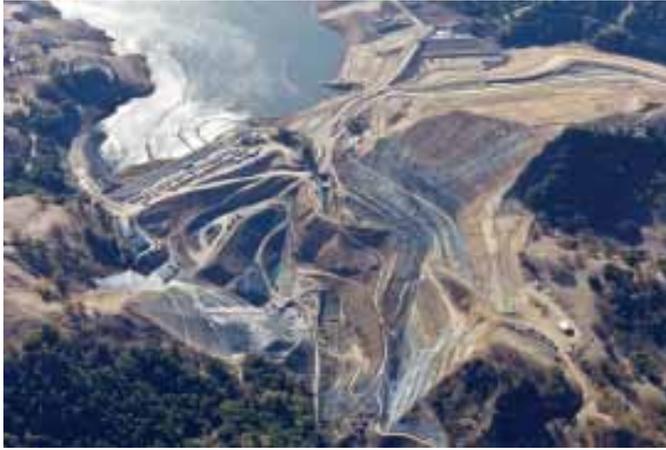
**Disposal Options** — Numerous options were identified for temporary and permanent storage. Cycle times were key to schedule and costs so the Team looked for nearby locations. Additionally, optimizing disposal locations had to consider the excavation stage. Referring to Figure 6 (next page), the best disposal location at the start of the left abutment excavation would be very different than the optimal location when excavating at the base of the dam, nearly 700 feet down. And, all additional storage locations would have to be designed, permitted, and readied for construction; in real-time while minimizing any impacts to existing operations.

Figure 6. Aerial view of left abutment.
